Black Mamba User Experience

From: Jensen, Jason M <JasonMJensen@eaton.com>
 Sent: Thursday, December 18, 2025 1:41 PM
 To: John Callies <calliesinc@comcast.net>
 Subject: Jensen Racing Overview

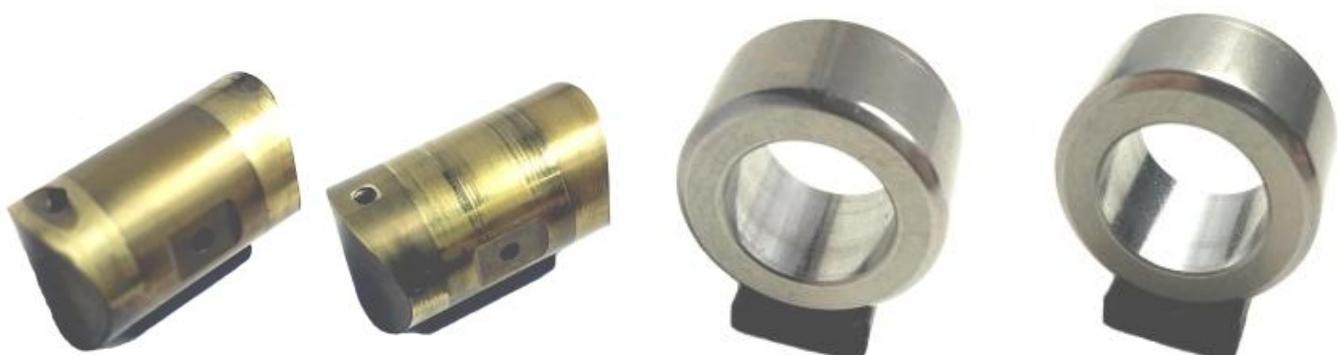
Parts Examination: After disassembly, the parts were examined. None of the wheels showed significant wear on either the exterior surface or the interior surface. The axle with the most wear was selected for photos. There was no wear on the top of the axle, as expected. The bottom of the axle supports the full pressure from the valve train springs and does show some slight wear. These photos show the effectiveness of pressurized oiling and oil-wedge lubrication.

Jason Jensen mentions that they check the lash 2-3 times per year and it never moves. An unstable lash is an indicator that the bottom end of the lifters is becoming sloppy. These photos show why the lash remained stable: Minimal wear shows that the bottom end tolerances were still acceptable and the lifters were still performing their assigned duty.

Axle – Top View

Axle – Bottom View

Wheel – Front Light

Wheel – Back Light
