Black Mamba User Experience

From: Jensen, Jason M <JasonMJensen@eaton.com>
 Sent: Thursday, December 18, 2025 1:41 PM
 To: John Callies <calliesinc@comcast.net>
 Subject: Jensen Racing Overview

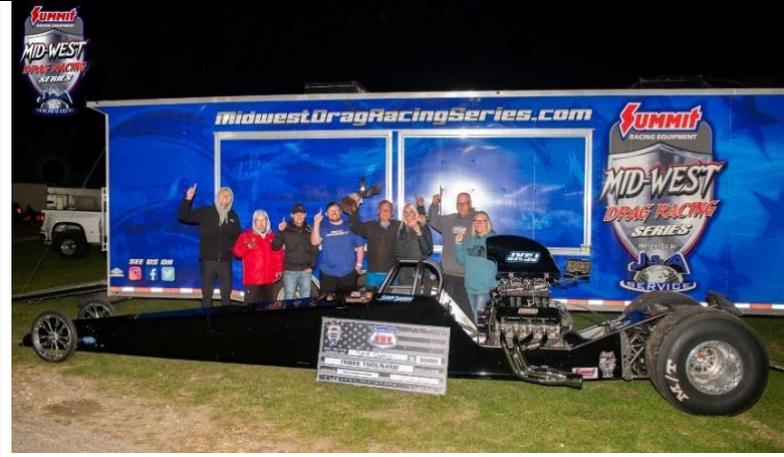
<p>Dragster</p> <p>2015 American with a 598ci BBC, driven by me Runs low 4.50's in 1/8th at 154mph. Shift at 7200, traps around 7400 Cam lift is .855/.814 Oil is Scheafer's Micron Moly 30wt Methanol for fuel Black Mamba Lifters # 6489</p>

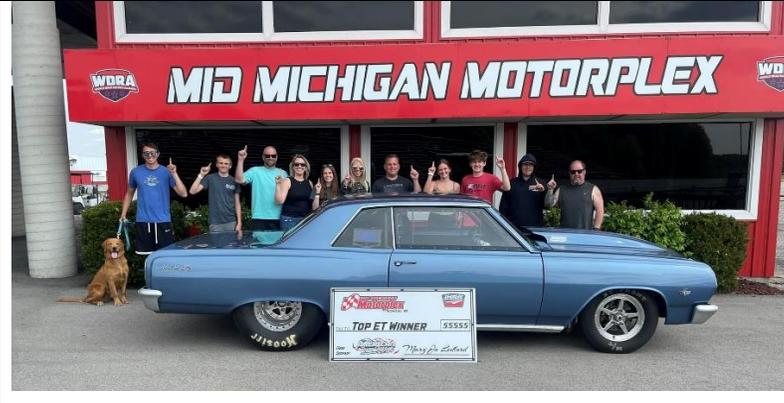
<p>Door car</p> <p>1965 Chevy Malibu with a 410ci SBC, driven by my son Conner Runs 6.0's in 1/8th at 113mph. Shift at 7200, traps around 7400 Cam lift is .704/.677 Oil is Scheafer's Micron Moly 30wt Methanol for fuel Black Mamba Lifters # 6475</p>
